TROUT RIVER

Environmental Committee

Annual Report 2022

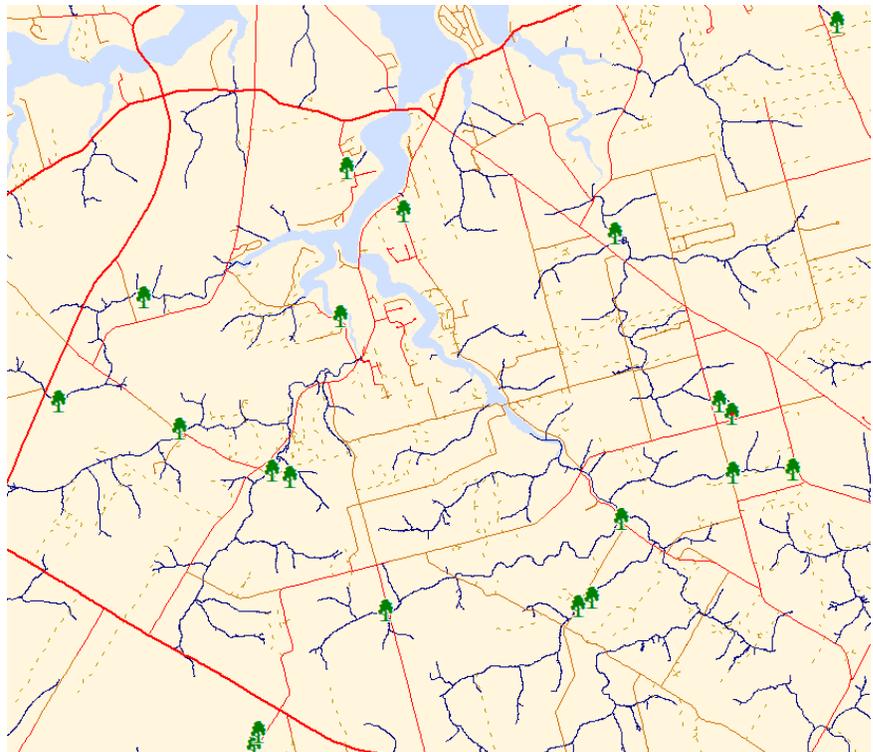
Figure 1. Locations of 1,711 native trees and shrubs planted in 2022.

This summer, TREC planted a total of 1,711 native trees and shrubs across 9 watersheds. An additional 587 trees and shrubs were given away to community members at the TREC Annual Tree Drive. In total, 2,298 trees and shrubs were planted this summer at 19 locations (figure 1.) as well as locations chosen by tree drive recipients.

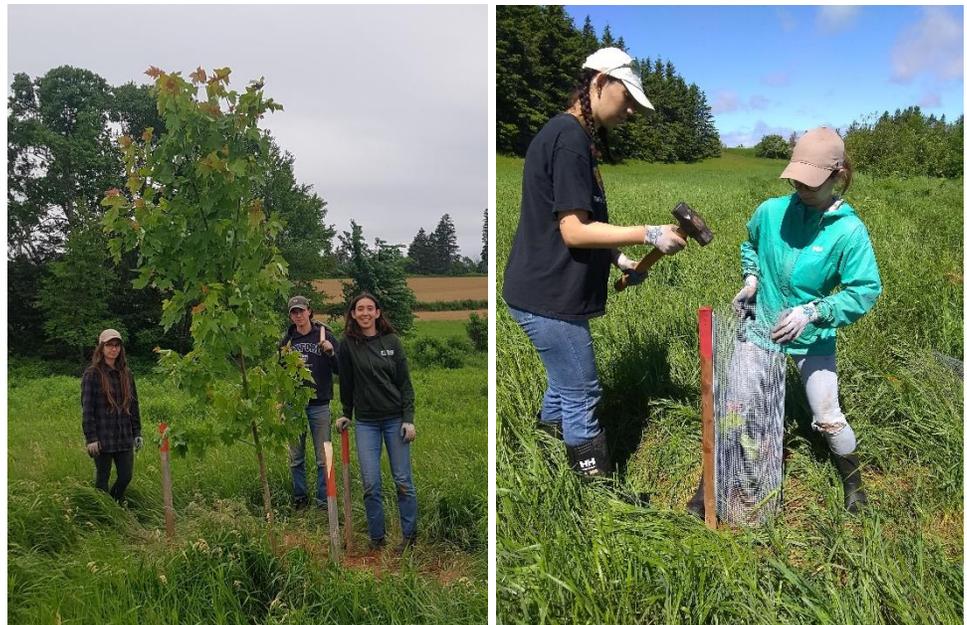
Figure 2. Teo, David and Ruby after planting a large tree at a headwater in Founds River Watershed, in a project to restore areas with low tree survival rates. This location was planting with Simon Wilmot, who organized this tree planting project through the PEI Watershed Alliance. Figure 3. (Right) Ruby and Teo caging a red maple.

TREC also caged deciduous trees wherever possible (figure 3.). Caging trees, especially deciduous trees such as oaks and maples, helps prevent predation, i.e. small animals using these saplings for food. In the future, these trees and shrubs will provide much needed food for birds and other wildlife. Berried shrubs such as red berried elder, elderberry, Aronia, and bay berry, provide food for bird species such as cedar waxwings, American robins.

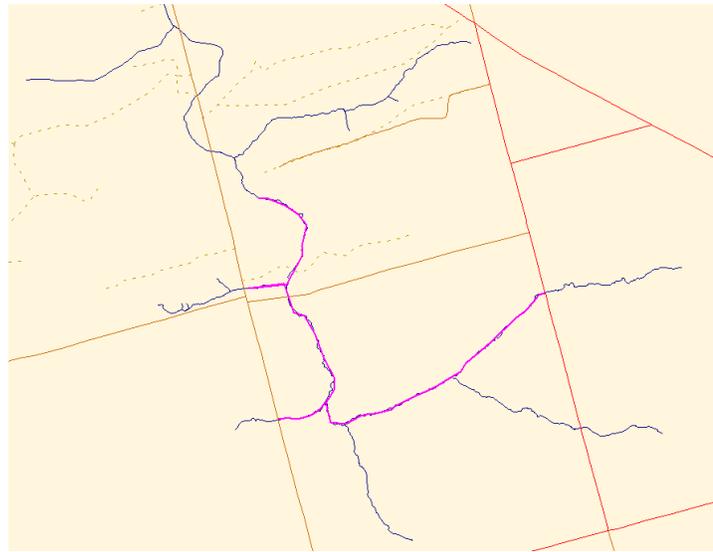
Figure 4. Stream Clearing on Hope River from St. Patrick's Road to Hope Valley Drive.

This field season, the team cleared parts of Hope River and Trout River, which were identified as blockage sites using past Riparian Health Assessments. 3.622km of stream was cleared in total, with 2.512 km cleared on Hope River from St. Patrick's Road Rte. 226 to the end of Hope Valley Drive (figure 4.) and 1.110 km were cleared on Trout River off of New Orleans Road (figure 5.). The team also assisted Kensington North Watershed Association with stream clearing within their watershed.

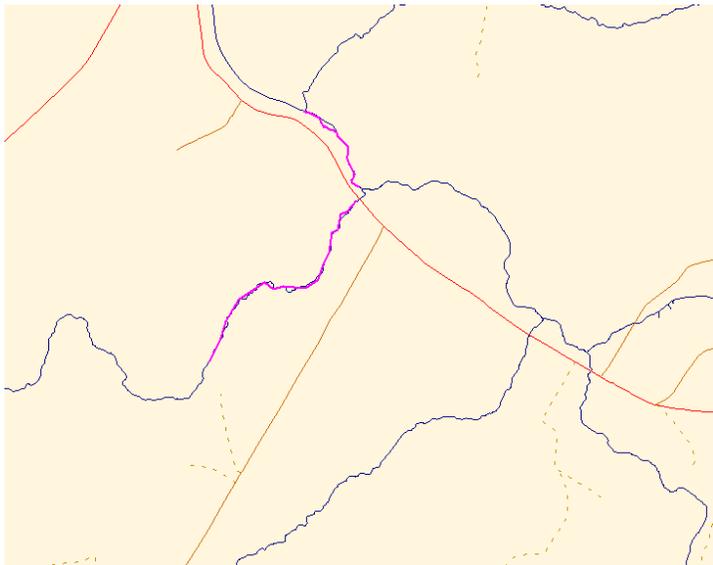
Figure 5. Stream Clearing on Trout River off of New Orleans Road.

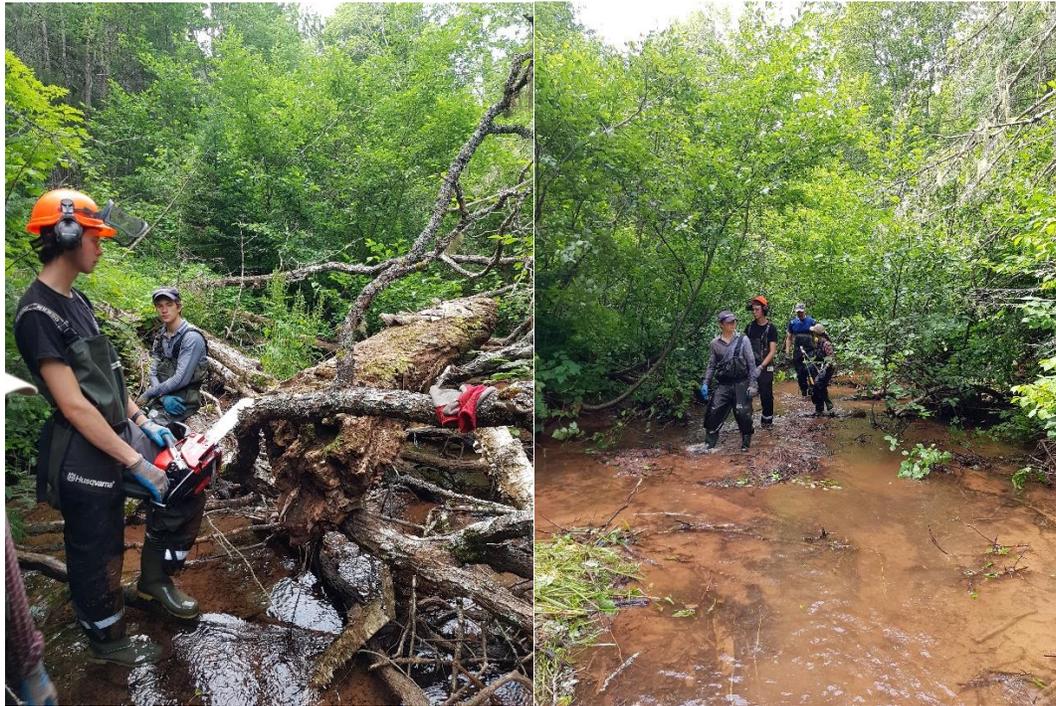
Figure 6. Stream clearing on Trout River off of New Orleans Rd. before and after. Brush mats were later installed.

When stream clearing, it is important not to completely clear away canopy cover, root mass and large woody debris, as aquatic species rely on trees and woody debris for shade, to keep waters cool, for habitat and for food. Only major blockages which may become worse over time, block fish passage, erode banks or cause other damage are removed (figure 6.).

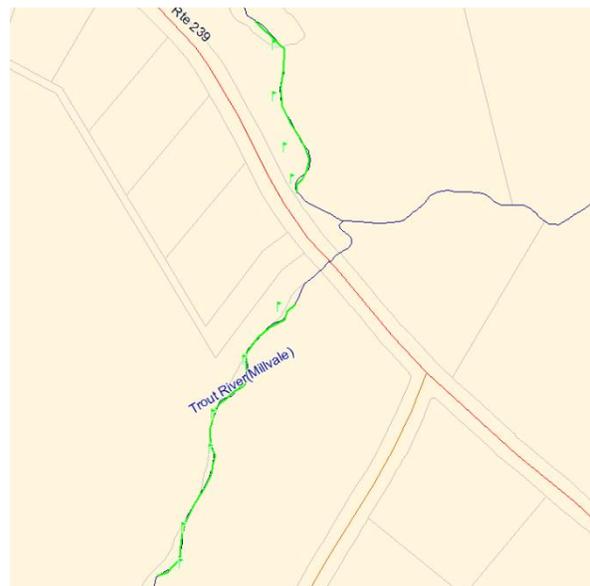
Figure 7. 10 new brush mats along Trout River on both sides of New Orleans Rd installed 2022 field season.

TREC built 10 new brush mats along the Trout River off of New Orleans road (figure 7.), and restored 1 brush mat built in 2019 on Hope River. The Trout River tributary on both sides of New Orleans Rd. is experiencing deep sedimentation and a straightening meander pattern, likely due to the road crossing, as well as damming downstream (figure 8.). This area, although in need of restoration work, is home to many large brook trout, muskrats, great blue heron, amphibians, waterfowl and other wildlife, that will now have improved habitat through a reduction in sedimentation and restored stream meander. TREC

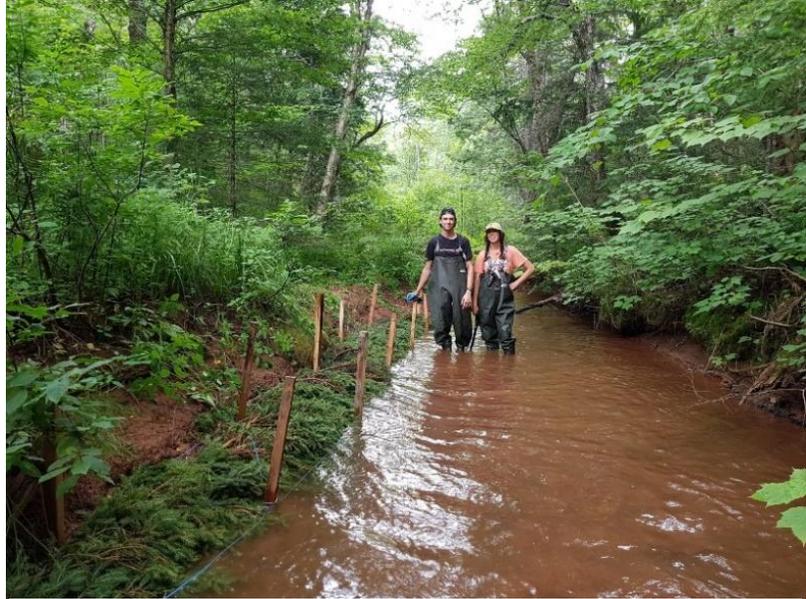
Figure 8. David MacLeod and Ruby Sharp standing next to a brush mat built on Trout River off of New Orleans Road.

then adding spruce between and overtop. Brush mats are then staked in place using wooden stakes and tied together using a triangular tying formation to keep the mat together during high flow and heavy rain events. Brush mats can also vary in length and width depending on the need of the area. Thank you to the North Rustico Home Hardware for donating the wooden stakes used to build these brush mats.

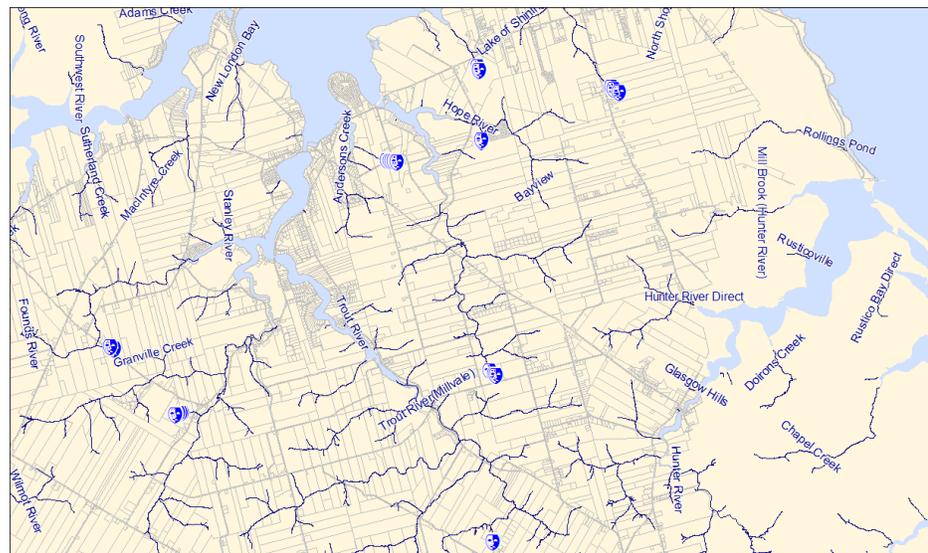
Figure 17. 2022 Headwater survey locations are shown as faces (heads) on the map.

Although the goal for the first year with these 5 new sites (figure 17.) was to collect baseline data from healthy locations, not all of the locations were deemed to be healthy due to land use issues, lack of canopy cover or sedimentation and are now listed as sites to be restored. Anderson’s Creek and Lake of Shining Waters headwaters were deemed unhealthy, and restoration work at the Lake of Shining Waters headwater began this summer, planting trees in the area. The Founds River and Hope River headwater were deemed healthy with problems, due to the spring being impacted by farming practices. The Trout River, Granville Creek, Bayview Creek and Grahams Creek headwaters were deemed to be healthy having lots of canopy coverage and headwater temperatures between 6 and 8 degrees Celsius. Additional sites may be chosen next year to continue to gather baseline data for healthy headwaters within our 9 watersheds.

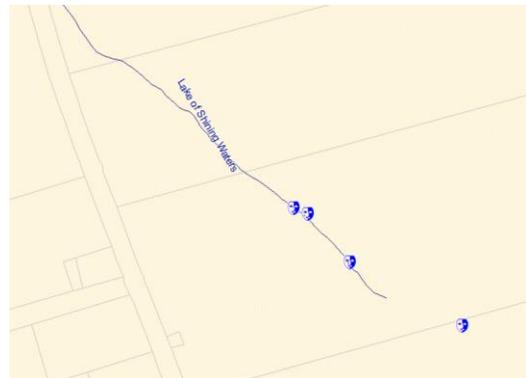
Figure 18. Each of these locations has several faces showing the exact points measurements were taken approaching the headwater.

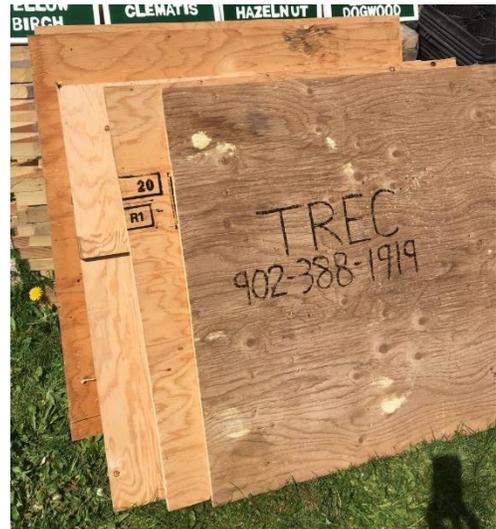
Figure 21 Amphibian Boards with labels

5 survey sites (figure 20.) were selected based on previous amphibian sightings, or suitable habitat such as a headwater, marsh or wetland, boards were placed along forest edges near these sites (figure 22.) in order to attract amphibians. Boards were left in the field for 2 months before checking underneath to see if amphibians were present.

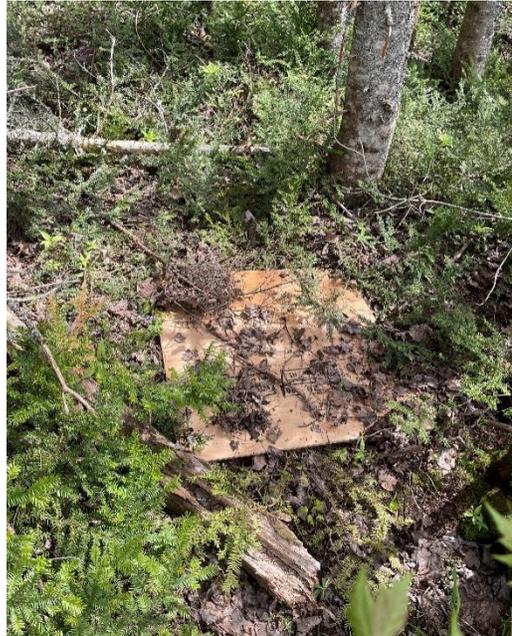
Figure 22. Board placement at survey site off St Mary's Road

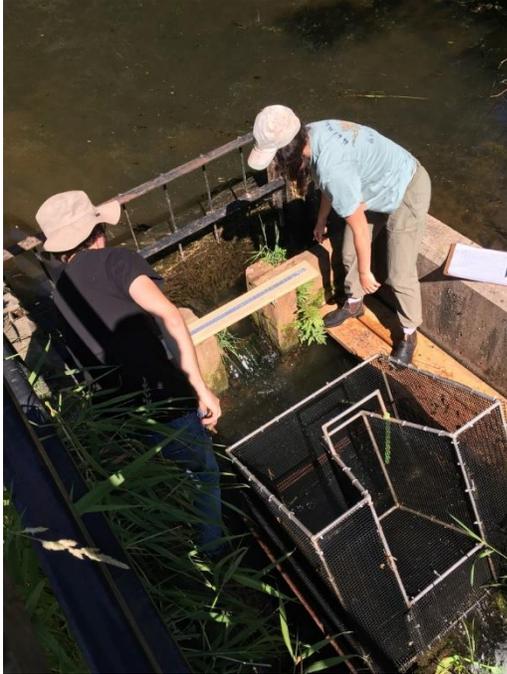
Figure 27 fish trap, figure 28. White Perch, Figure 29 Brook Trout.

Brook Trout (figure 29.) were the most prominent species found in the fish trap, followed by Gaspereau and White Perch (figure 28.). Only one Gaspereau at a length of 24cm and one White Perch at a length of 20cm were found. In addition to checking the fish trap each morning and removing for weekends, the team also cleared the ladder of any debris or plant life that could impede fish passage. The trap was removed August 25th at the end of the summer field season.

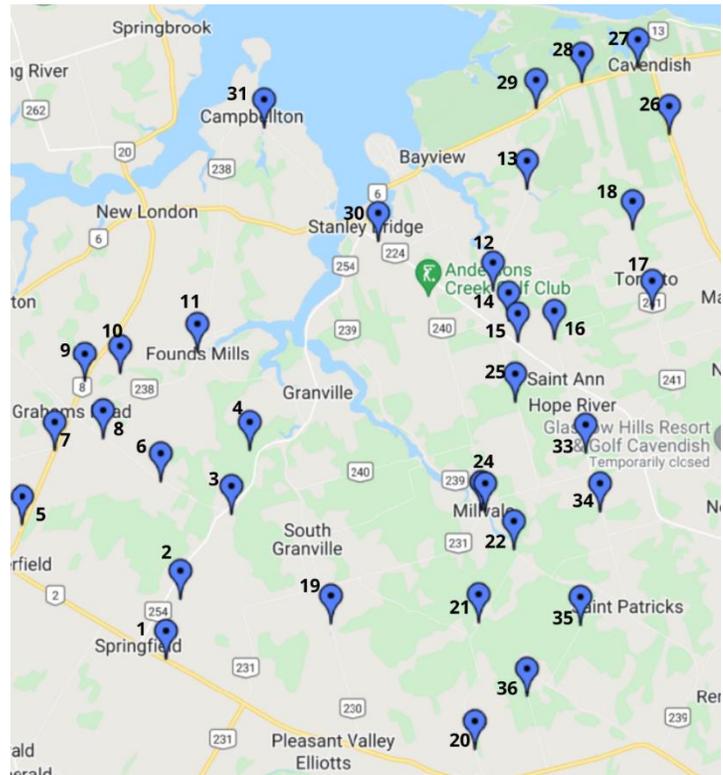
Figure 32. 33 bi-weekly Water Quality Monitoring locations for 2022

Every other week, the team recorded stream characteristics (width, depth, sediment depth and flow) (figure 33.) as well as its physical and chemical characteristics (temperature, pH, turbidity, conductivity, dissolved oxygen, TDS/TSS, nitrogen content, specific conductance, and salinity). We do this to have an up to date reading of water quality for this area to compare to past and future data and track the health of our streams. All data, along with past data will be uploaded to Atlantic DataStream, an open access website which can be referred to by anyone. This greatly enhanced our understanding of both the physical properties (turbidity, stream depth, water flow and temperature), and chemical properties (nutrient, metals, minerals, and pollutants).

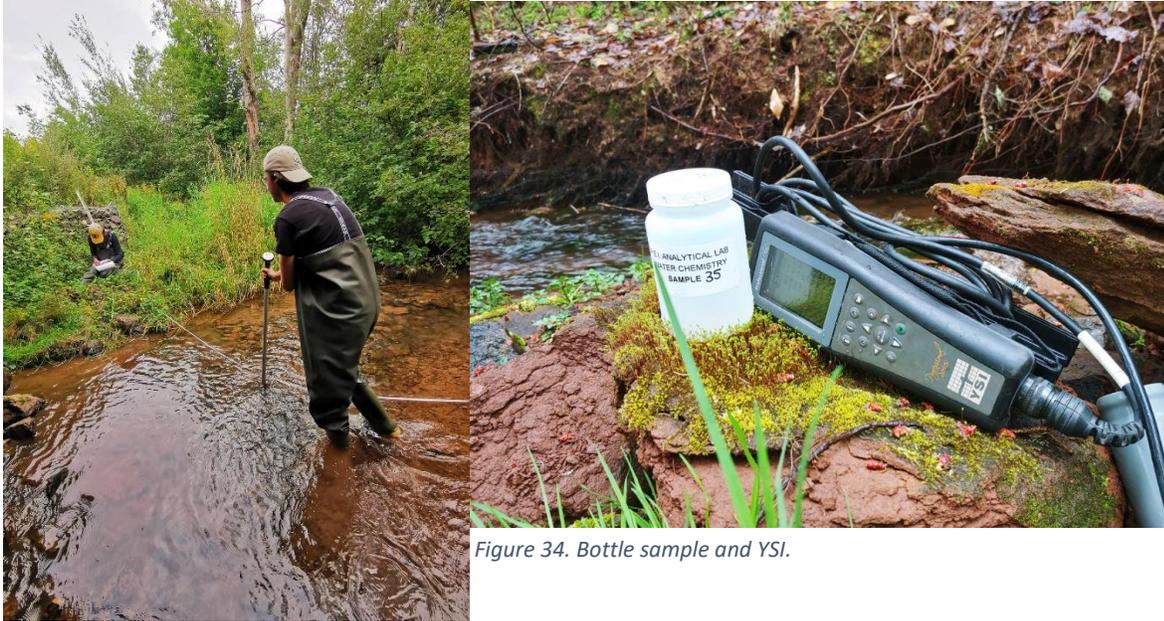
Figure 34. Bottle sample and YSI.

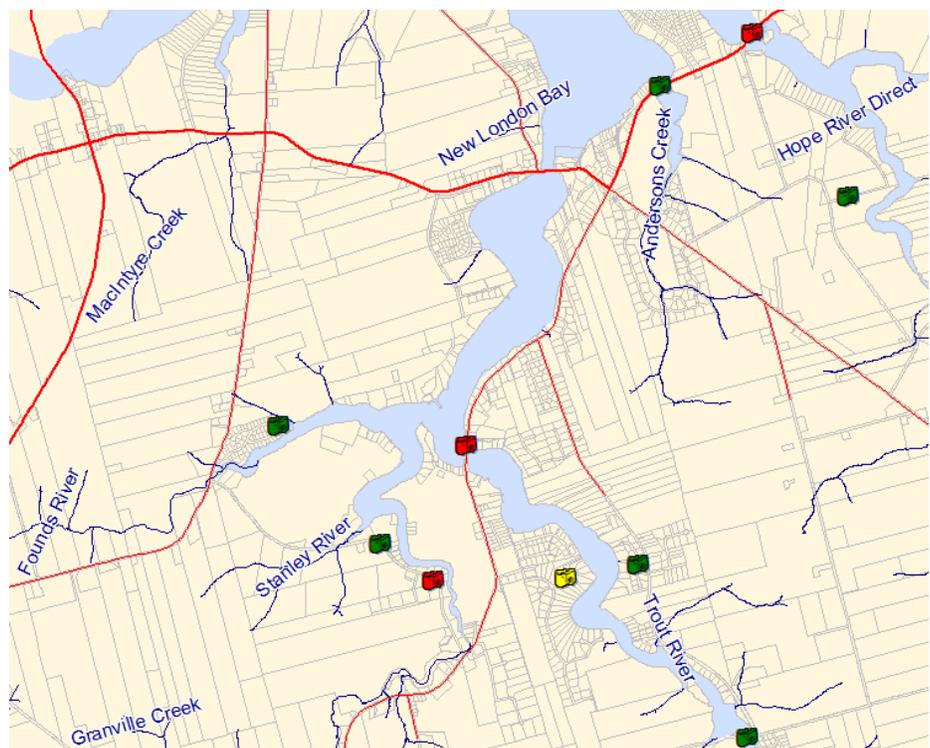
Figure 35. Estuary watch locations. Red markers are sites retired from monitoring. Yellow markers are sites that are proposed as good future alternative sites. Green sites were monitored in 2022 by staff and volunteers.

Used to track anoxic events, estuary watch protocol and booklet is a standardized program used across the province. TREC conducts these assessments every Wednesday afternoon at 6 locations for estuaries within Hope River, Trout River, Granville Creek, Founds River and Anderson Creek (figure 35.). At the end of the monitoring period, we relay all data to the provincial government, who collects data Island wide on anoxic events. Knowing where anoxic events are happening and the duration of these events in our estuaries provides valuable data to us and the Department of Environment, Energy and Climate Action.

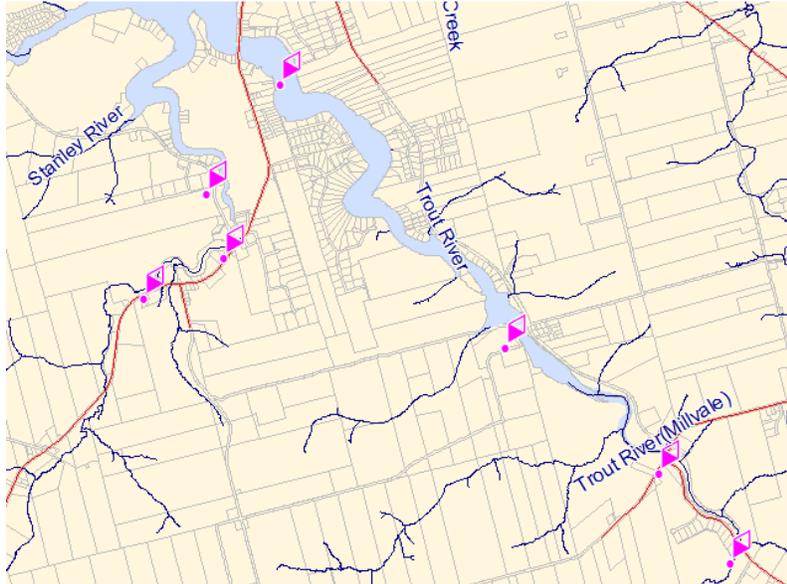
Figure 36. Six temperature loggers and 2 DO loggers continue to collect data for Granville Creek and Trout River systems.

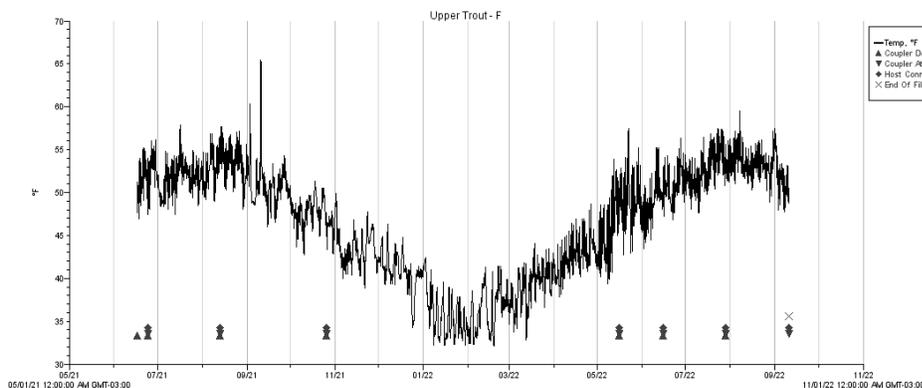
These temperature monitors will log data for the next 5 years and are offloaded and data analysed monthly (figure 37).

Fish and other aquatic organisms can be impacted by elevated temperatures, or sudden changes in temperature. It is also important to track changes in temperature in order to track how climate change and other factors are impacting stream health, and if stream temperature is increasing year to year.

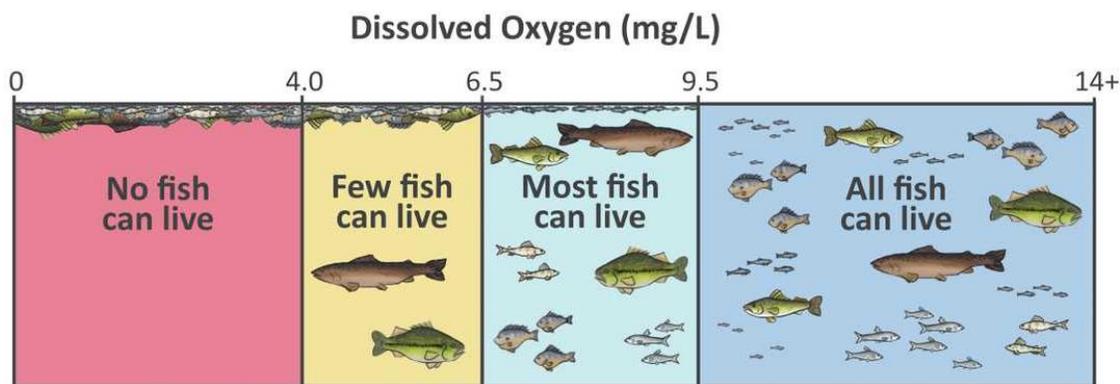
Figure 38. This figure explains how dissolved oxygen below 5.5 mg/L will negatively affect most fish and fish life stages. Each species of fish requires a different amount of dissolved oxygen to live, some are more sensitive than others. (Atlantic Datastream)

When dissolved oxygen levels are too low, fish and other aquatic organisms can suffocate, impacting mortality rates. Extremely low oxygen levels in estuaries happen at the end of summer when sea lettuce growth has peaked and is has began to decompose, eating away oxygen in the process. In polluted systems with too many nutrients, mostly nitrogen and phosphorus, an overgrowth of plants matter, and even animals, and bacteria cause the oxygen to be used up quickly, sometimes causing the death of aquatic organisms. You can find data from these temperature and DO loggers on Atlantic DataStream, uploaded annually.

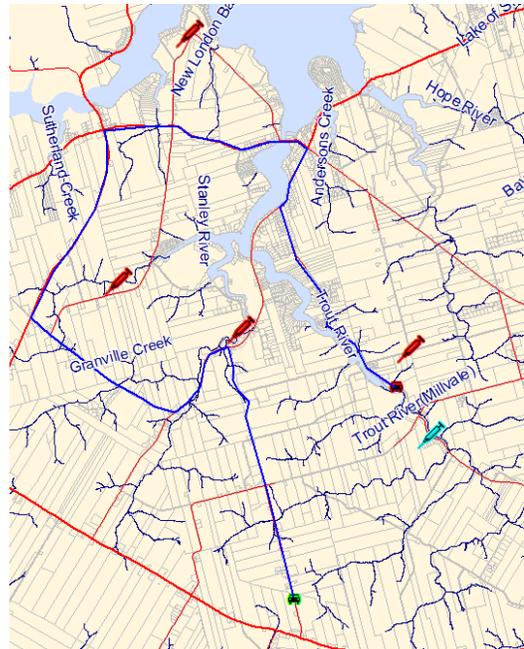
Figure 39. TREC conducts bat monitoring throughout the year during roosting and hibernation peak seasons. The red symbols are stationary monitors which collect data for one week during the summer roosting season. The blue line is a driving transect.

The PEI Watershed Alliance, under the Habitat Stewardship Program, initiated a bat monitoring program under the NABat framework. This project will last three years with a major focus on detecting bats. We are currently in our second year. Since the fungus that causes white nose syndrome was introduced to North America, bat populations have decreased drastically across much of the eastern coast. The fungus causes the hibernating bats to emerge too early from hibernation in search of food, when food is not readily available. The NABat framework aims to standardize bat monitoring efforts across North America by creating standards of practice and grids. TREC was given one grid square to monitor over the 2021/22 field season. Using acoustic monitors that detects the high frequency echolocation calls of bats, we can determine bat presence or absence (figure 39.).

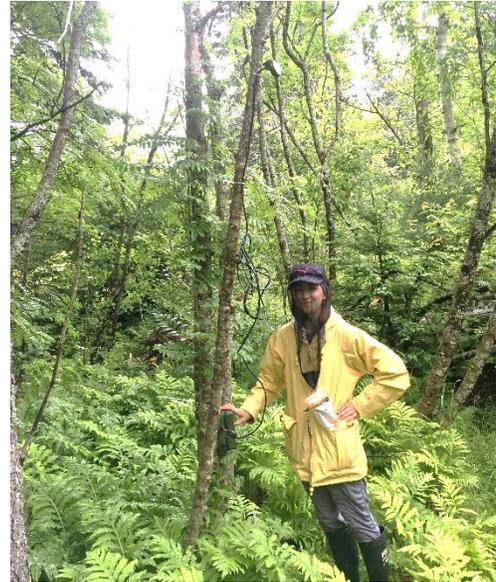
Figure 41. Shayla Steinhoff, installing a stationary monitor in a forested area. The monitor is below, and the microphone is installed above, facing an open area.

Five stationary monitors were installed at different habitat types (forest, open field, wetland, stream) around the watershed for a week during peak roosting season (figure 41.). These monitors collect data on what species are in the area. This data is then analysed using a program called Kaleidoscope and used by the NA Bat Program and the Canadian Wildlife Health Cooperative to track bat populations on the Island. The TREC watershed area is particularly batty compared to other parts of the Island. If you see a bat or bats on your property please report it to the Canadian Wildlife Health Cooperative.

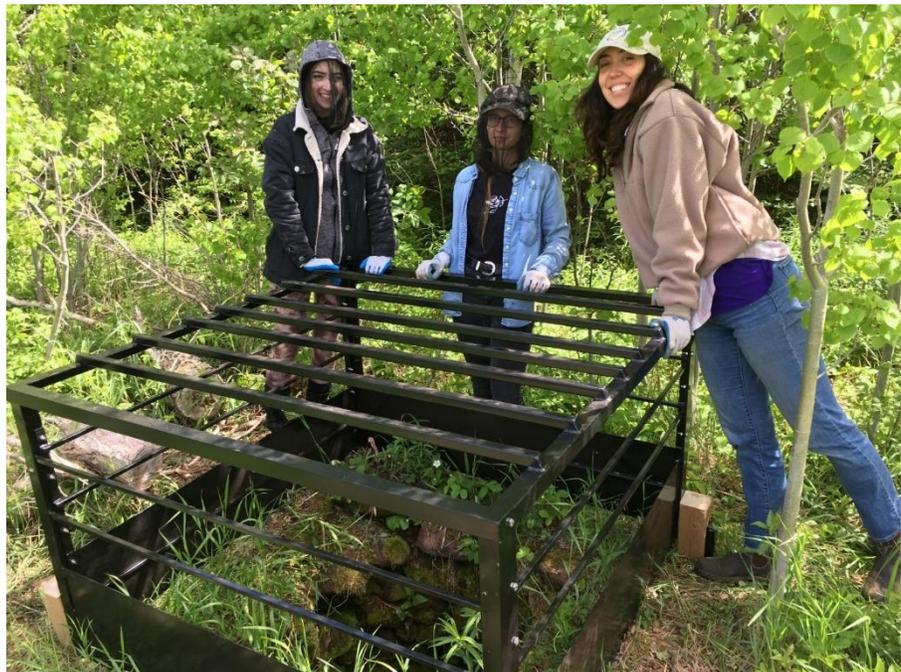
Figure 42. Teo Bujenita, Ruby Sharp and Shayla Steinhoff after installing the first of two well covers over one of our well monitoring sites.

Recently discovered, bats hibernate in hand dug wells on PEI. Sandstone wells may be used as hibernaculum for cave-dwelling bats on PEI or for mating swarms. TREC monitors these wells each winter to determine if they are suitable hibernation sites, and if they are being used. This is done by collecting temperature and humidity data from within the well, as well as recording bat calls to see which species are using the wells. A metal powder coated cover was installed at one of the wells this summer by crew members with funding from the Wildlife Conservation Fund in order to protect this well and stop anyone/thing from accidentally falling in, while allowing bats to pass freely through 6-inch gaps (figure 42.).

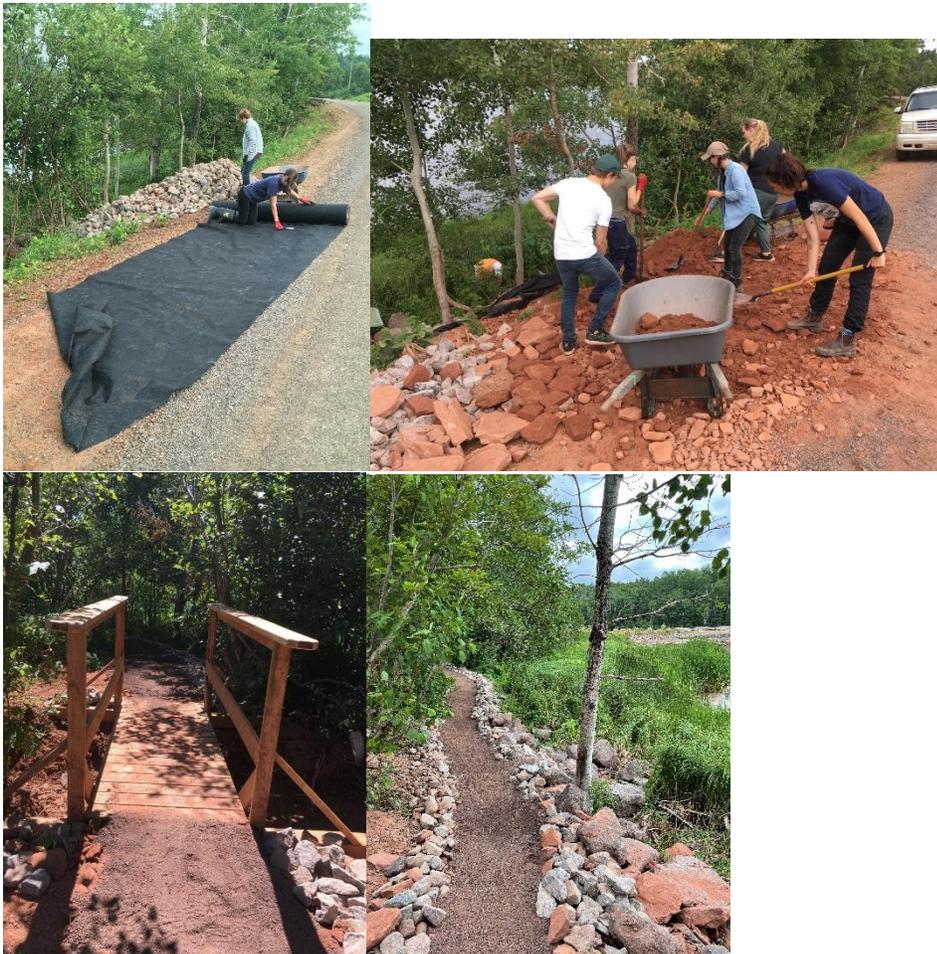
Figure 43. Work completed on the Trout River Park Trail

With the help of volunteers and Kensington North Watershed Association, the crew completed work on the trail connecting to Gunns Bridge. Using rock, gravel and trail mix donated by Transportation, the crew built up the trail as to not be washed away by the surrounding waters (figures 43.). A bridge was installed to replace an existing infilled culvert as well (figure 43.). This work was conducted over a week's time and was funded by The Active Transportation Fund. Thank you to all who helped out!

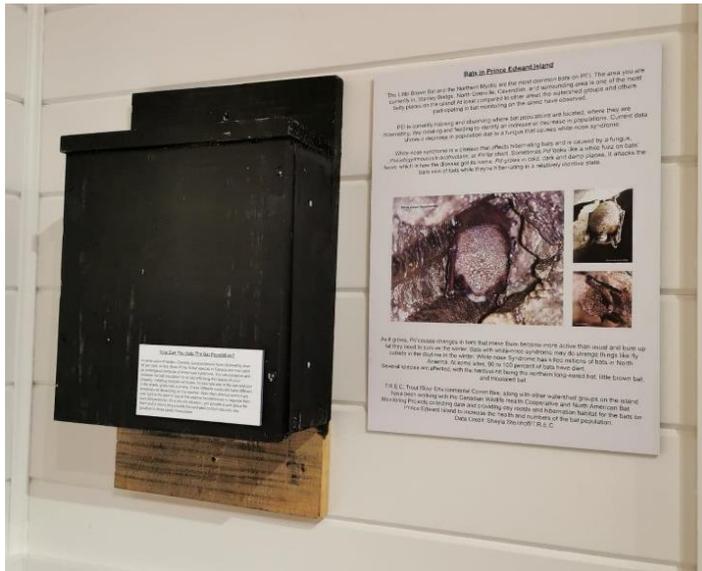
Figure 45. TREC bat box donated to Carr's Wildlife Centre with accompanying informational sign

Bat boxes are used by bats to roost and can hold up to 50 bats. These boxes do not require maintenance but may be periodically checked for use using emergence surveys, or noting bat droppings below. The team built an additional 5 bat boxes (figure 46.) and donated 1 previously built, to Carr's Wildlife Centre to be used in an educational display (figure 45.). These 5 bat boxes will be installed at suitable locations around the watershed.

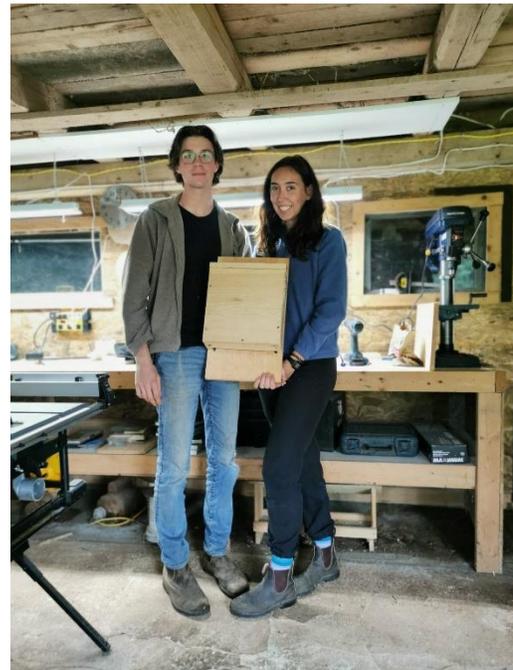
Figure 46. David Macleod and Ruby Sharp holding a bat box before it is painted.

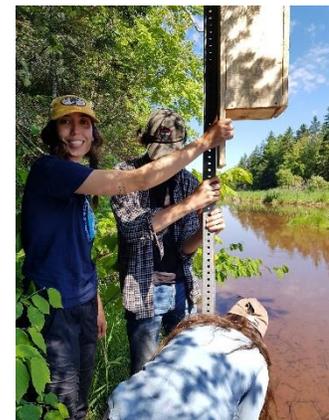
Figure 47. The team installing a wood duck box along Trout

Thanks to a generous donation from a community member who built these Wood Duck boxes, as well as Transportation for supplying us with signposts, TREC was able to install 2 Wood Duck Boxes in wetlands within the Trout River (figure 47.) and Granville Creek systems. Wood shavings will be placed in the boxes each spring before wood ducks begin utilization, the boxes will then be checked after use to determine success rates.
